Elliott Bay Seawall Project: 2018 Post Construction Monitoring Report (Year 1)

City of Seattle Department of Transportation

Anchor QEA, LLC
720 Olive Way, Suite 1900
Seattle, Washington 98101

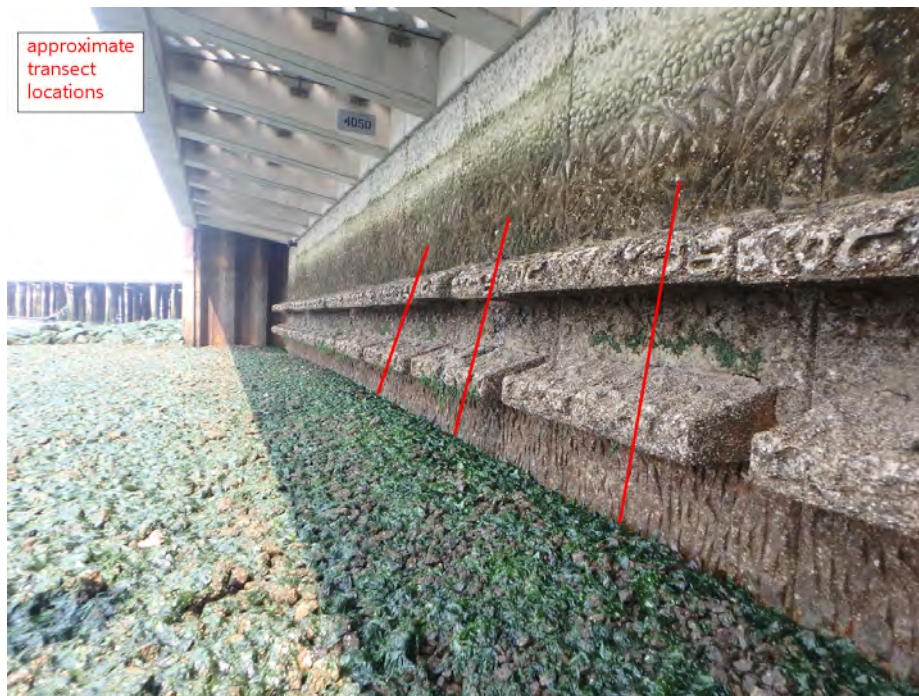
Photograph 1
August Monitoring Aquarium North Site Uncovered Monitoring Area

During the April monitoring at the uncovered areas of the Aquarium north and the Pier 55 sites acorn barnacle (*Balanus glandula*) was the most common species observed, occurring within all 24 quadrats. Thatched barnacle (*Semibalanus cariosus*) was the second most common species.

Additional frequently observed species at the Aquarium north site included mussels (*Mytilus sp.*) and black tar (*Mastocarpus papillatus*). Shield limpet (*Lottia pelta*) was also frequently observed at the Aquarium north site, and plate limpet (*Tectura scutum*) was frequently observed at the Pier 55 uncovered site. Biofilm was also frequently observed at the Pier 55 site, covering bare surfaces and invertebrate species. No biofilm was observed at the Aquarium north site.

During the August monitoring at the uncovered areas of the Aquarium north and the Pier 55 sites, common species observed were similar to the April and June observations and there was an overall continued increase of species variety and density. Acorn barnacle was the most common species occurring within all 24 quadrats, and thatched barnacle occurred in most of the quadrats.

At the Aquarium north site, mussel presence decreased from the June surveys, occurring in 6 of the 12 quadrats. Shield limpet was observed in 10 of the Aquarium north quadrats and all 12 of the Pier 55 quadrats. Black tar was observed in all 12 of the Aquarium north quadrats and 7 of the Pier 55 quadrats. Biofilm was covering bare surfaces and invertebrate species in half of the Pier 55 quadrats and was observed in one of the Aquarium north quadrats.

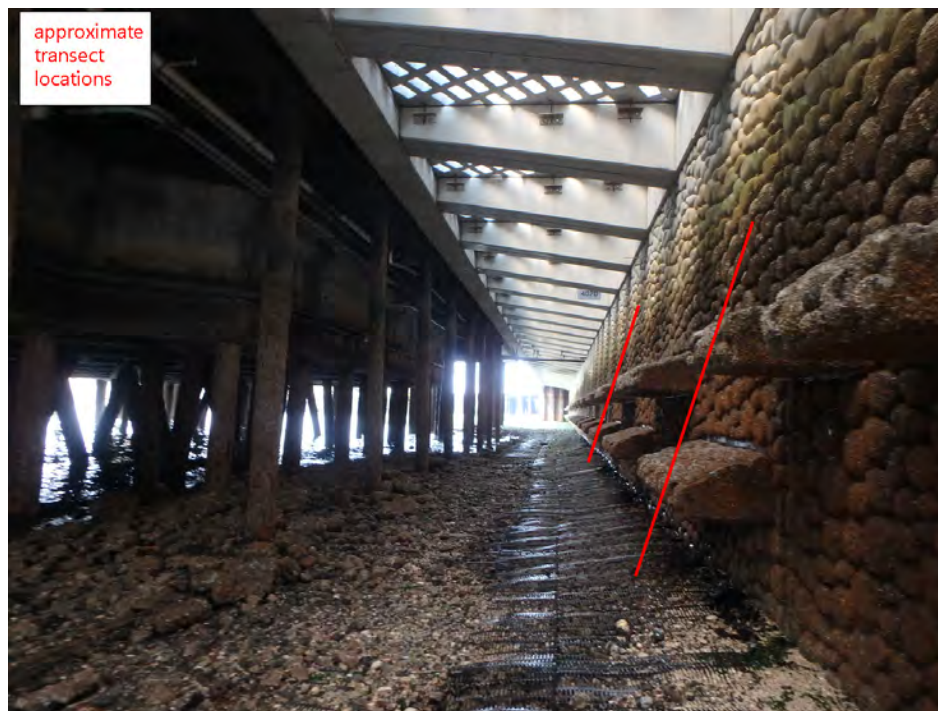
Photograph 3

August Monitoring Aquarium North Site Covered Monitoring Area

barnacle, and thatched barnacle were observed in several of the Aquarium north and Pier 55 sites. Bryozoan was present in a majority of both the Aquarium north and Pier 55 quadrats.

Shield limpet was observed in seven of the Aquarium north quadrats and six of the Pier 55 quadrats. Black tar was observed in four of the Aquarium north quadrats and nine of the Pier 55 quadrats. Biofilm was covering bare surfaces and invertebrate species in three of the Pier 55 quadrats and one of the Aquarium north quadrats.

Algae species presence during the August monitoring was infrequent with green string lettuce occurring in two of the Aquarium north quadrats and one of the Pier 55 quadrats. Sea lettuce was observed in four of the Pier 55 quadrats. Examples of the August monitoring Aquarium north and Pier 55 covered quadrats are shown in Photographs in Appendix C.

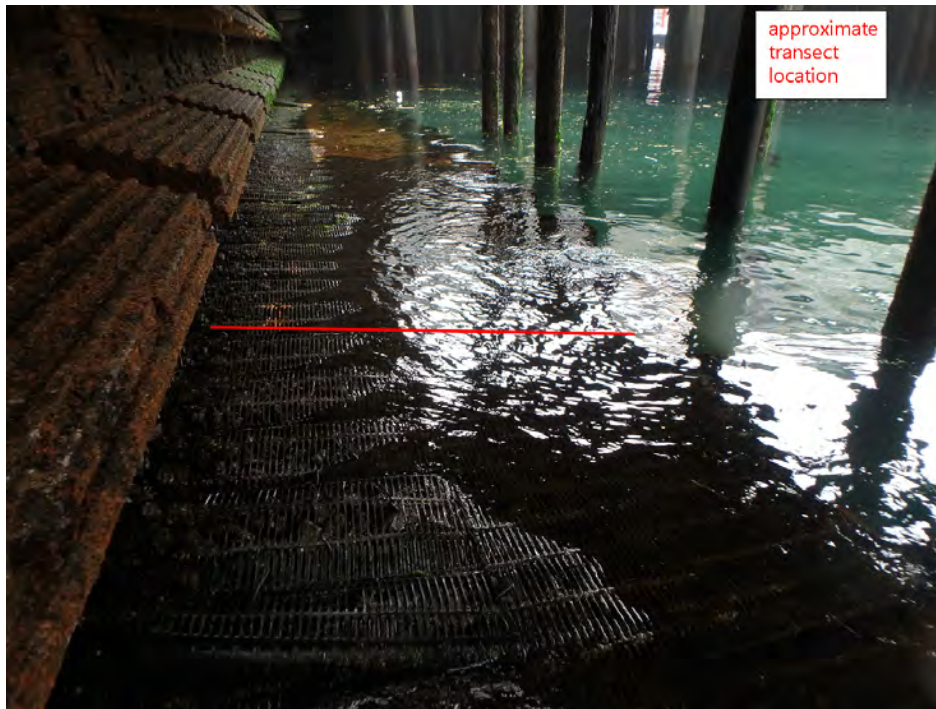
Photograph 8

Unattached sea lettuce was observed within two quadrats of the Aquarium north site and red hair was observed within two quadrats of the Pier 55 site. No macroalgae was observed at the Aquarium north site expanded bench. Examples of the August monitoring Aquarium north and Pier 55 covered bench quadrats are shown in Photographs in Appendix C. The Aquarium north and Pier 55 covered bench monitoring areas are shown in Photographs 7 and 8.

August Monitoring Pier 55 Site Covered Bench Monitoring Area

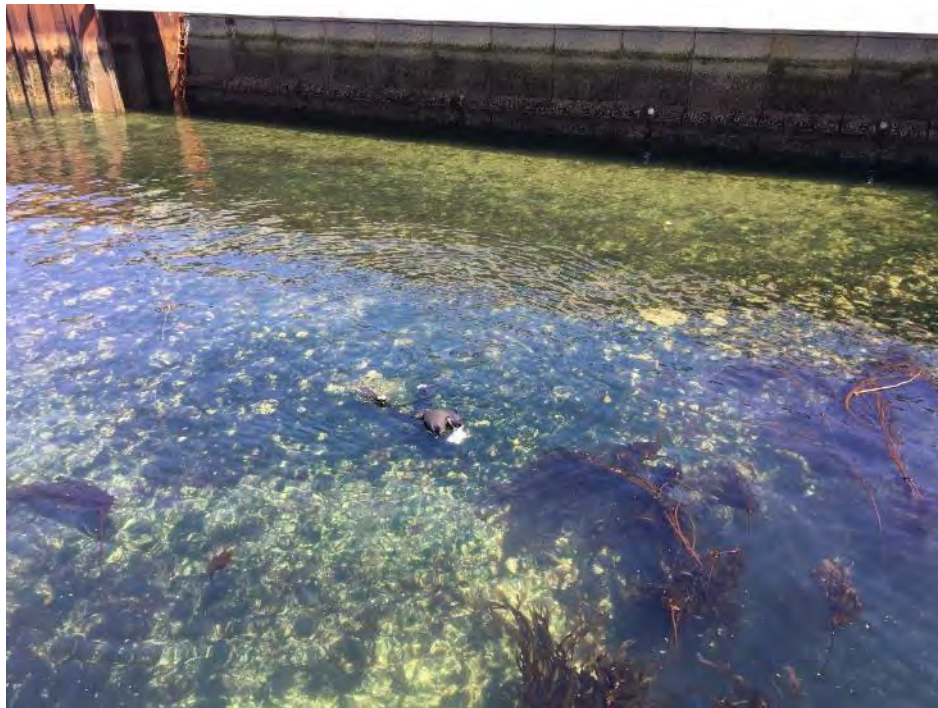
Bull Kelp Around the Periphery of the Extended Bench at the Aquarium, June 2018

At the Aquarium site, numerous under-pier pilings precluded conducting a deep transect at the base of the sheet pile. Instead, this effort was shifted to surveying a 30-meter transect around the perimeter of the extended bench in between the piers.

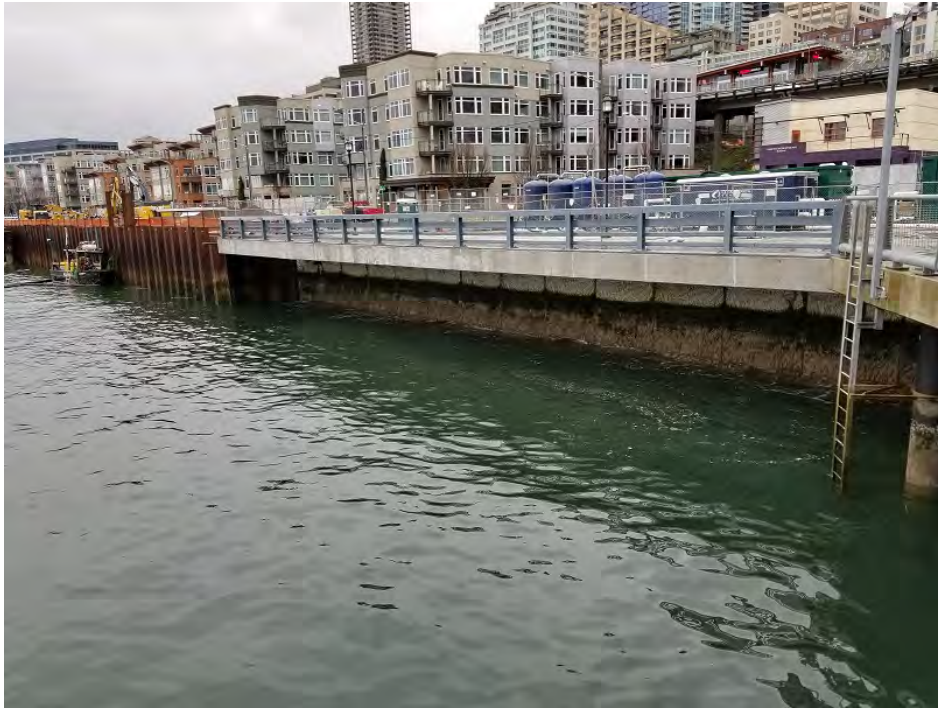
Photograph B3

Seawall North of the Aquarium, Showing the Terminus of the Phase I Rebuild During 2018

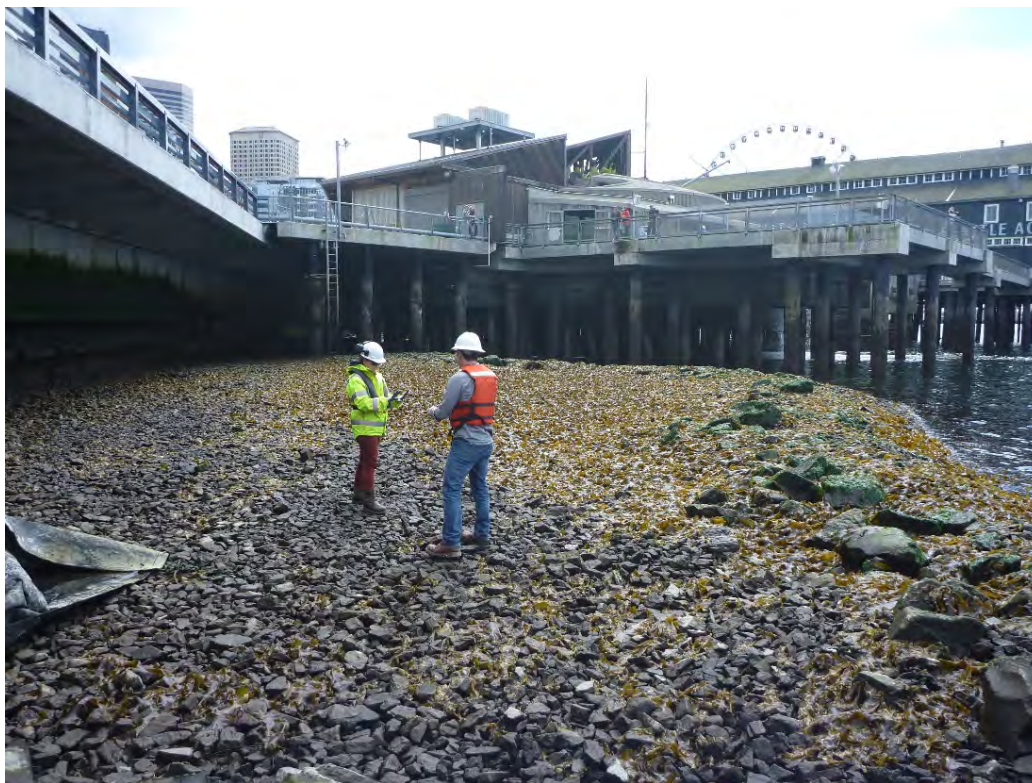
Photograph B7

Extended Habitat Bench North of the Aquarium Pier, at Low Tide
